**SERVICE
BULLETIN**

1984

1984 Service Bulletin Book

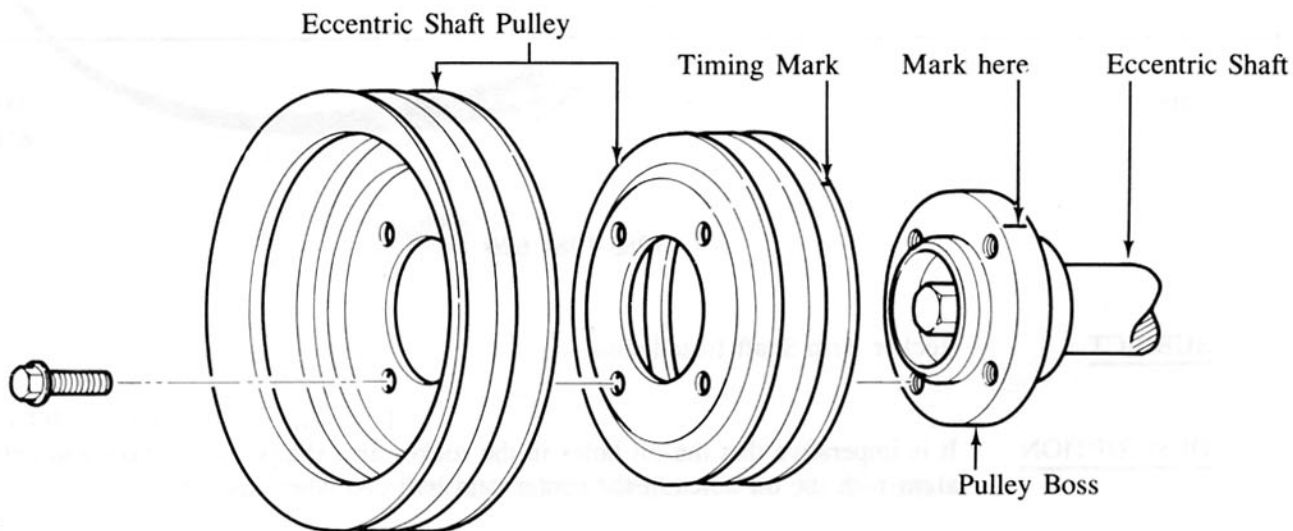
No alignment dowels are provided for aligning the eccentric shaft pulley to the eccentric shaft on later model RX-7 vehicles. Consequently, the pulley may be misaligned during reinstallation, resulting in an incorrect location of the timing mark.

For this reason, whenever the eccentric shaft pulley is removed, please mark the location of the timing mark on the pulley in relation to the eccentric shaft in order that the pulley may be reinstalled correctly.

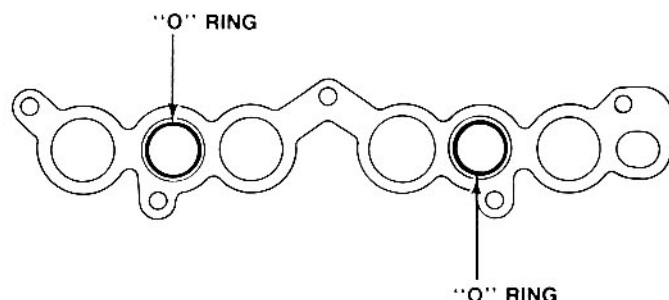
DESCRIPTION The material of intake manifold gasket for 1981 and 1982 GLC has been changed for better sealing along with inserting two (2) "O" rings onto the gasket.

Please note that the "O" rings may be detached from the gasket easily if you bend it. Handle the gasket with care and make certain the "O" rings are in place prior to installing the intake manifold.

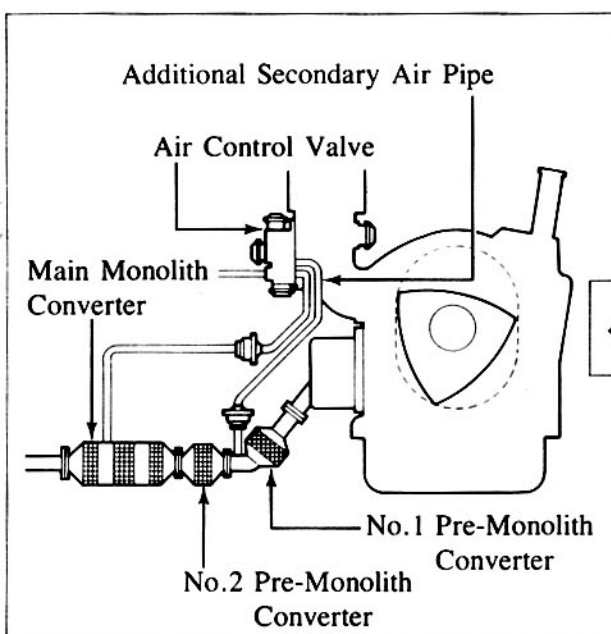
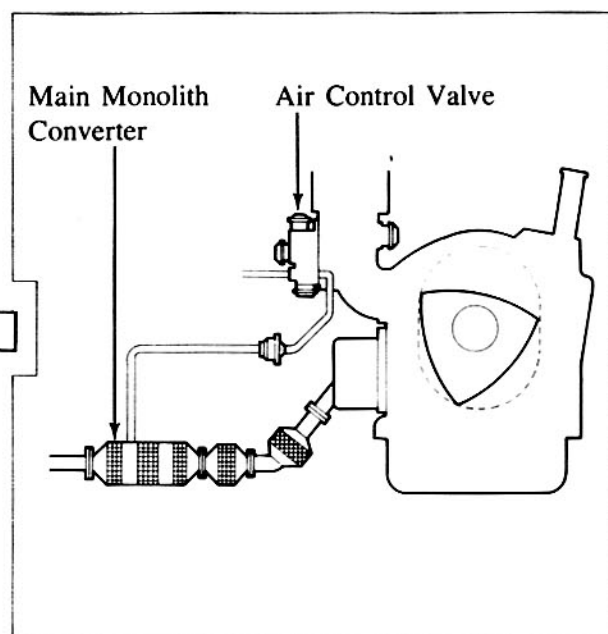
DESCRIPTION The Secondary Air Control System has been modified since the production date of March, 1984.

Now air is injected behind the No.1 pre-monolith converter when the Port Air Switching Valve (newly added to the Air Control Valve) is open. Port and split air operation remain the same as previous years.

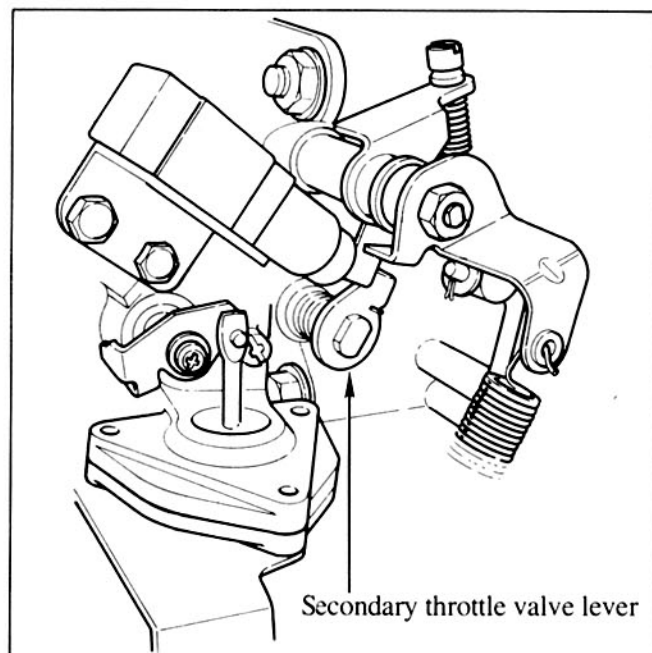
DESCRIPTION If you encounter either of the following problems on 1984 RX-7 (13B) vehicles with the engine fully warmed, please follow the repair procedure listed below:

If this procedure corrects the problem, the high idle is due to sticking of the secondary throttle valve. Replace the throttle chamber (N304 20 500B) in this case.

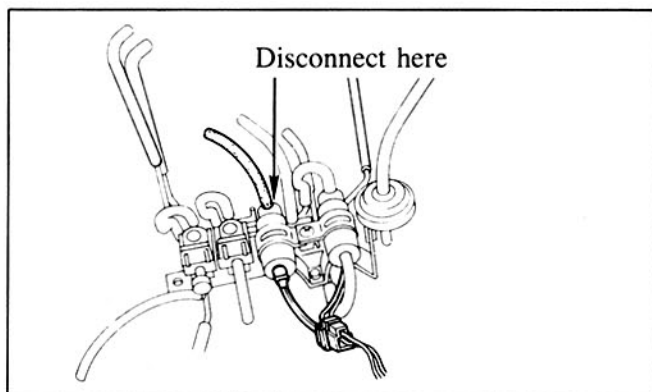
Disconnect the vacuum hose from the vent solenoid valve and plug the inlet port of the vent solenoid valve with a finger as shown while the idle speed is high or hunting.

If this procedure corrects the problem, the high idle is due to a faulty vent solenoid valve. Replace the vacuum switch valve (N304 13 240), which includes the vent solenoid valve, in this case.

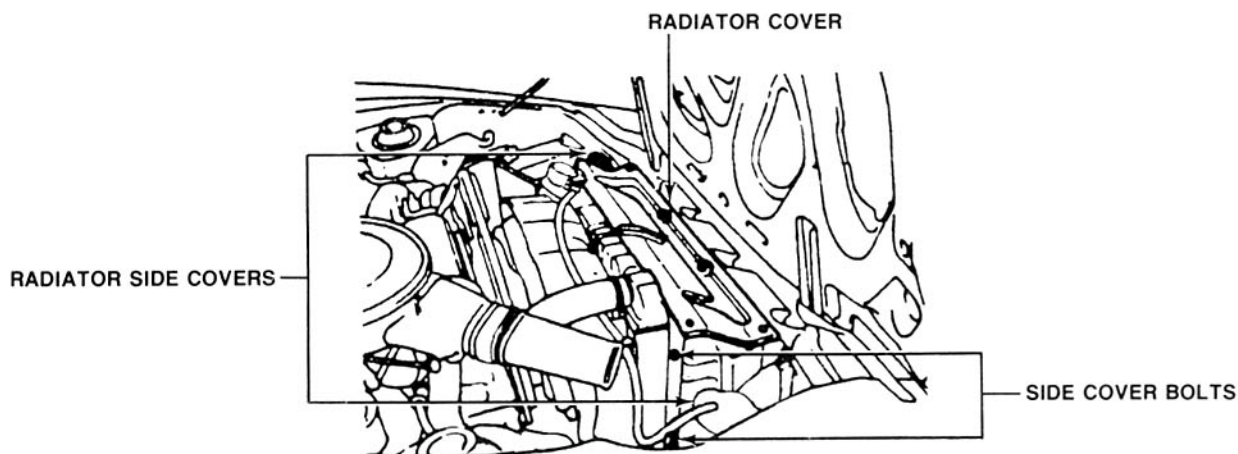
DESCRIPTION The dimension between the radiator side covers may be insufficient for installation of the condenser. To overcome this problem, loosen the two bolts securing the right side cover prior to installing the condenser. This will allow the right side cover to move outward far enough to enable the installation of the condenser. Be sure to tighten the side cover bolts after the condenser is installed.
