| Section | Applicable Model/s | Subject | Bulletin No. | 001/00 |
| 00 | Multi | TECHNICAL ASSISTANCE HOTLINE | Issued | 11/20/00 |

## BULLETIN NOTE

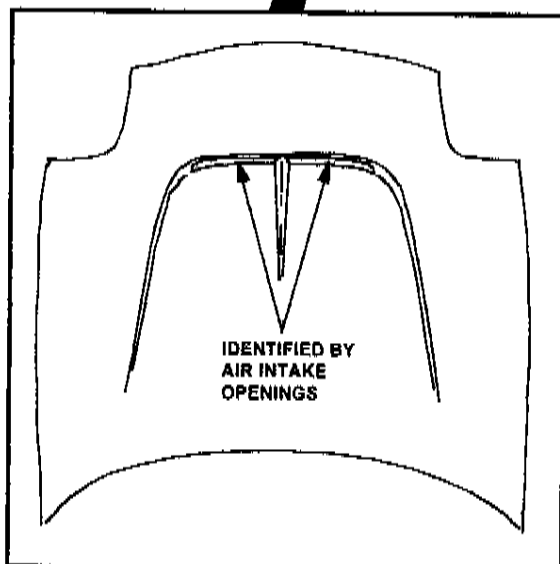
**MAZDASPEED HOOD**

Mazda Motor Corporation has determined that a defect, which relates to motor vehicle safety, exists in certain 1993 through 1995 model year Mazda RX-7 vehicles accessorized with the Mazdaspeed Carbon Fiber Hood. **Only vehicles that had the original factory-equipped hood replaced with the accessory Mazdaspeed Carbon Fiber Hood are affected.** Originally equipped, factory-installed hoods are *not* included in this campaign.

- If the vehicle **does not** have a MAZDASPEED HOOD, this campaign does not apply and no repair work is necessary. Return the vehicle to the customer or inventory.
- If the vehicle **does** have a MAZDASPEED HOOD, proceed to "B. REPAIR PROCEDURE."

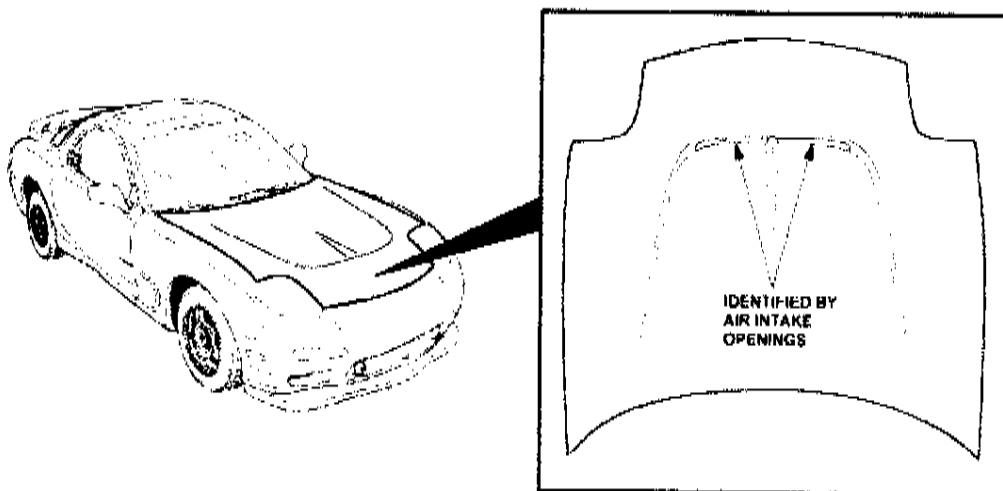
Please reference the picture below to identify the Mazdaspeed Carbon Fiber Hood. In addition, a Mazdaspeed identification label is affixed underneath the hood. If you are still not sure that your hood is the Mazdaspeed Carbon Fiber Hood accessory, please contact your local Mazda dealer for verification.

Your Mazda dealer will inspect and replace the hood striker with a modified one. This repair will be done at **no cost to you**. This inspection and repair should take approximately 1.0 hour to complete, however, this repair includes an application of epoxy that requires an additional 24 hours of curing time. Please allow one day for the repair.

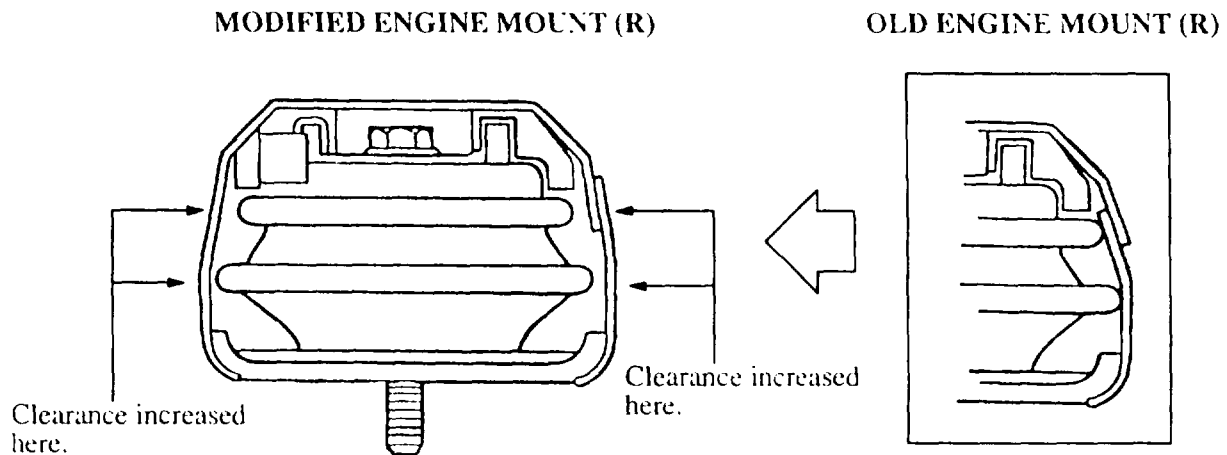
If the above condition occurs, replace the right engine mount with a modified part. The clearance between the rubber mount and mount housing has been increased to eliminate the noise.

Vehicles produced after the May 31, 1992 production date come with the modified right engine mount.

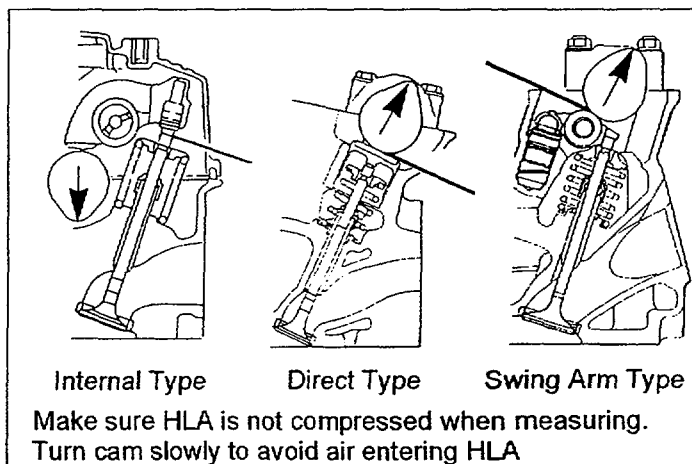
If the HLA is suspected as the cause of the noise item "c", identify the faulty HLA and replace **only those that require replacement**. Use the method below to determine which HLA requires replacement.

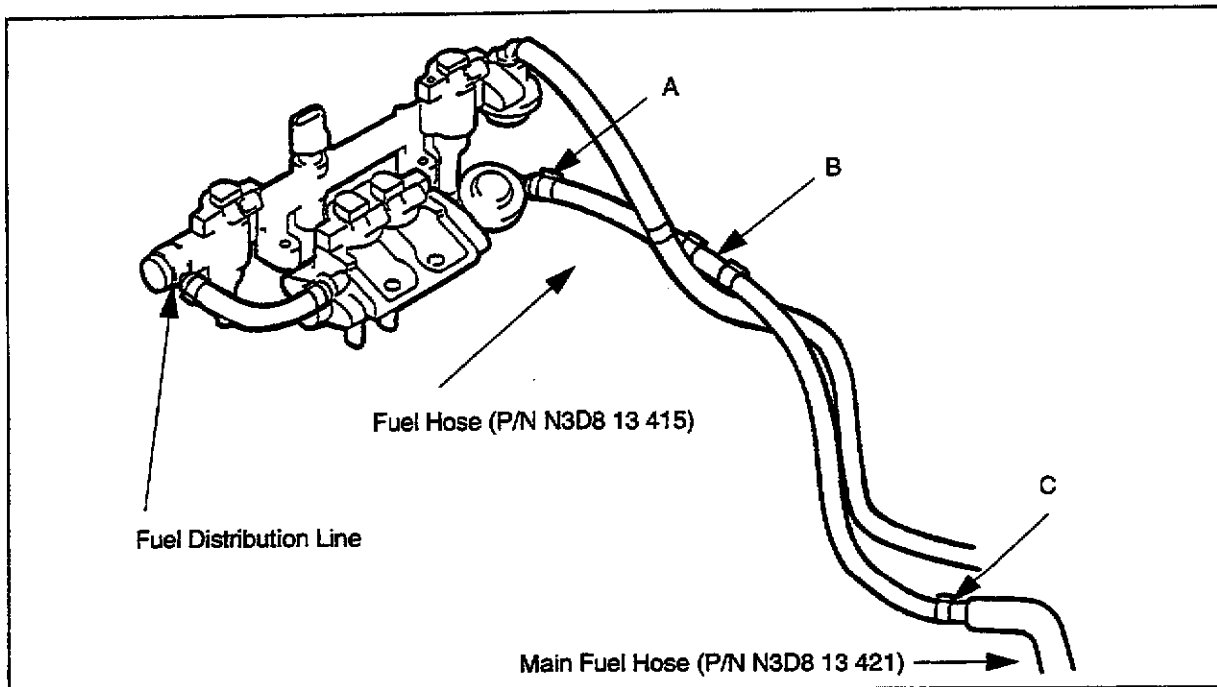
When removing an engine from any of the above mentioned vehicles, disconnect the main fuel line from the other side of the adhered spot (Refer to area "C").

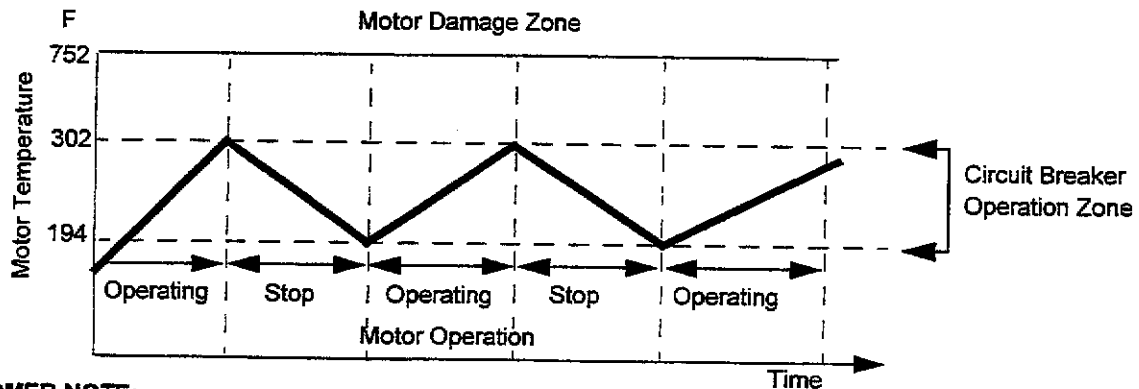
The information in this bulletin is provided to answer customer questions regarding occasional wiper motor perceived problems and prevent unnecessary wiper motor replacement.

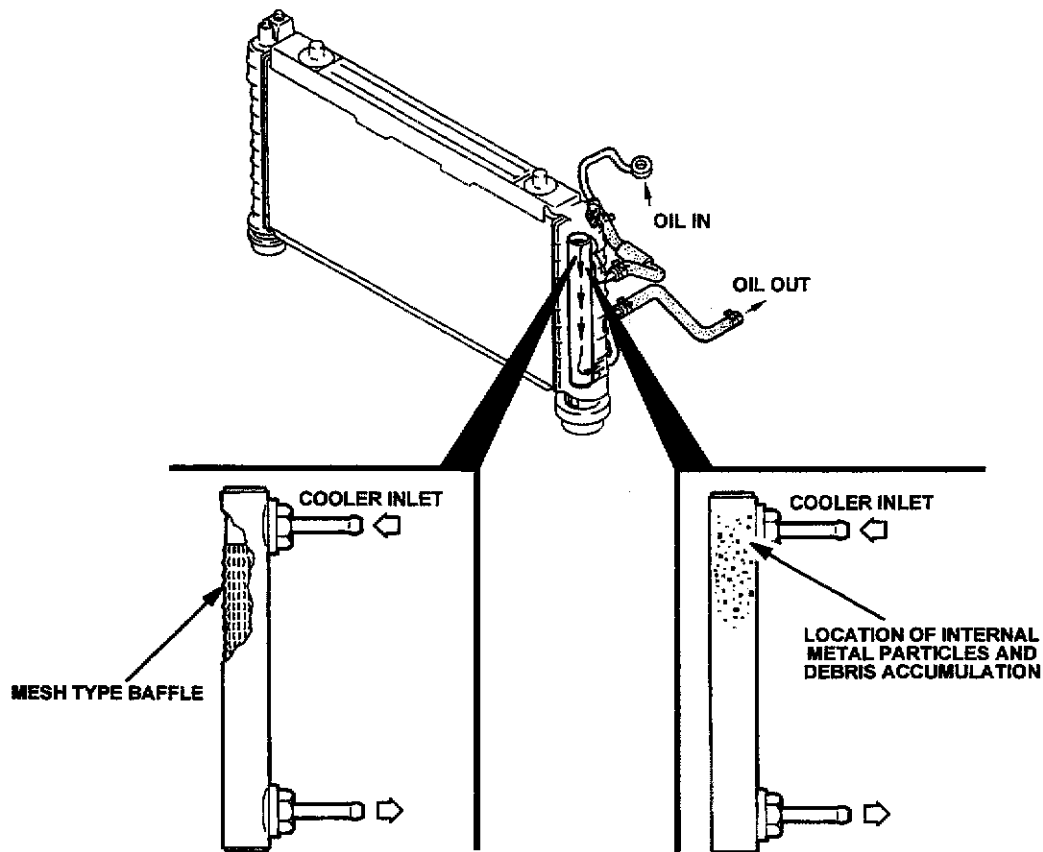
FIGURE 1

Automatic transmission (A/T) oil cooler/lines must be power flushed completely before an overhauled or replacement A/T is installed. One of the causes of repeat A/T failures is an internal automatic transmission fluid (ATF) restriction at the inlet side of the oil cooler. This restriction is usually caused by an accumulation of metal particles and debris (from a previous A/T failure) on the internal mesh type baffle of the oil cooler. Power flushing will remove the restriction by back flushing the cooler/lines followed by forward flushing to ensure full ATF flow. See **FIGURE 1** of a typical ATF cooler.

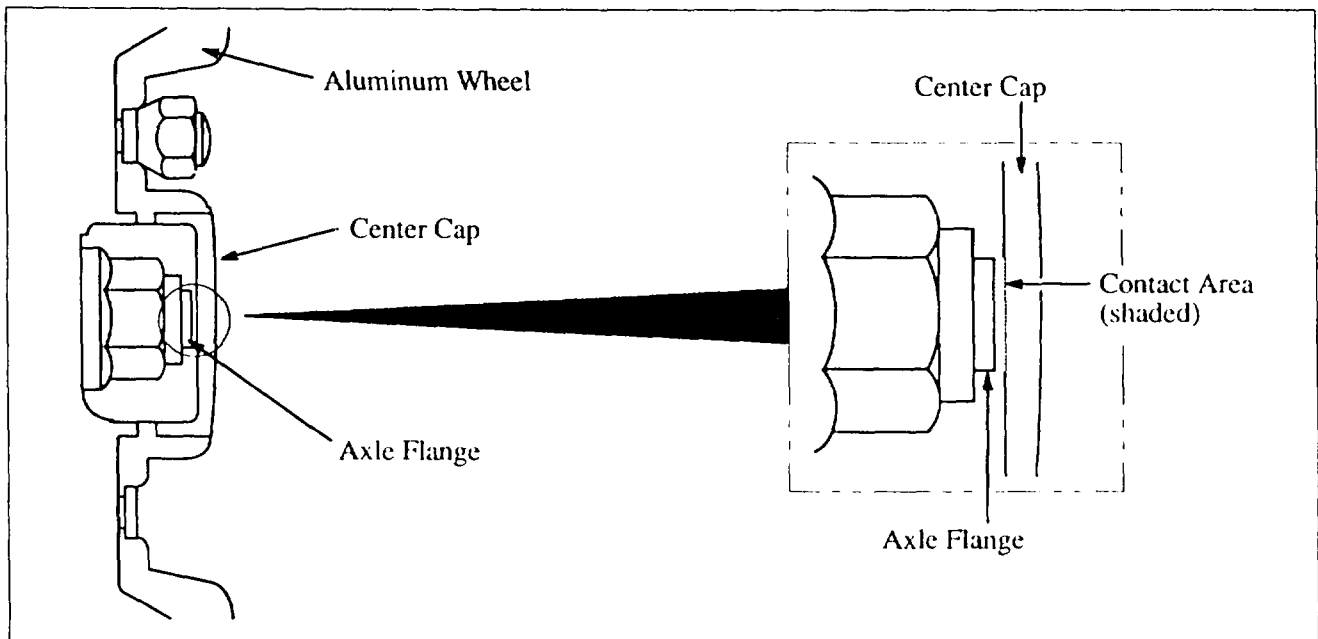
Some vehicles may have aluminum wheel center cap(s) that do not fit flush with the wheel. This is caused by the contact between the cap and the axle flange. See figure below.

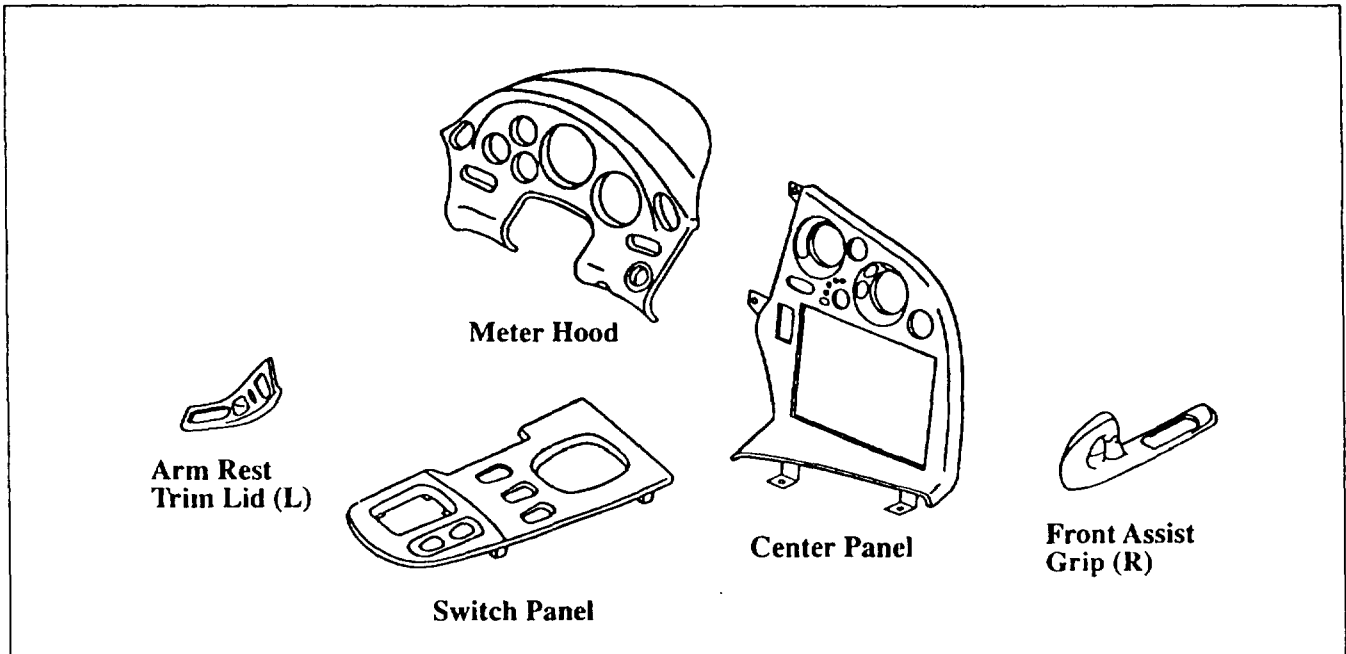
This condition is caused by poor adhesion of the black finish to the trim parts.
