**SERVICE
BULLETIN**

1984

1984 Service Bulletin Book

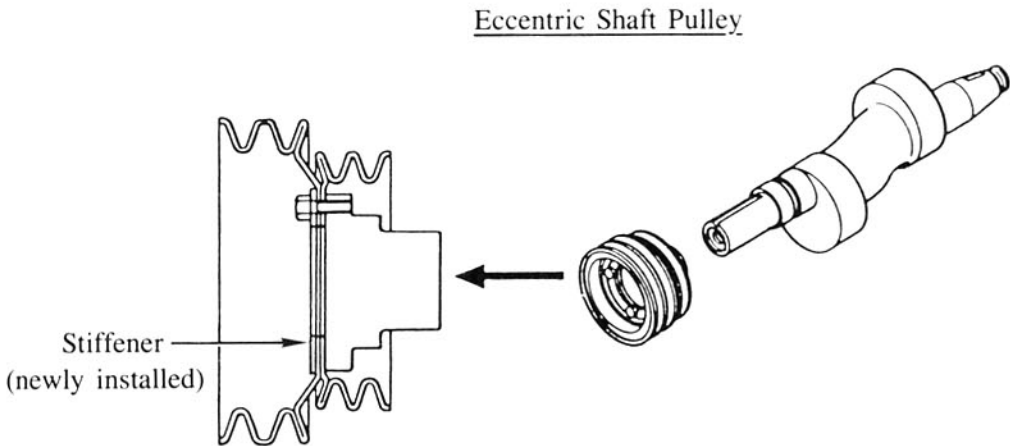
DESCRIPTION A stiffener has been installed on the eccentric shaft pulley since the production date of August, 1984.

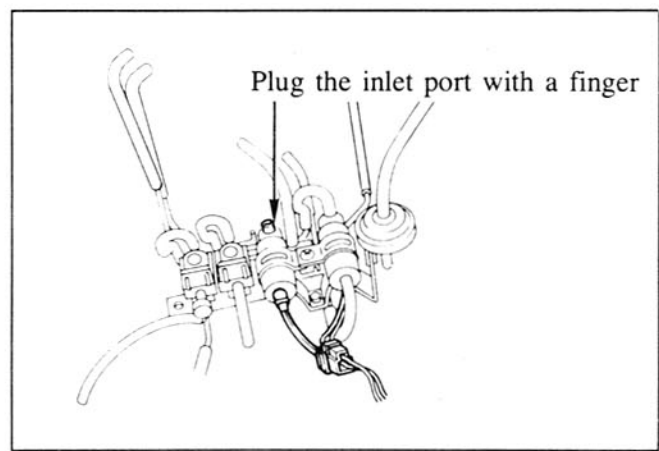
If this procedure corrects the problem, the high idle is due to a faulty vent solenoid valve. Replace the vacuum switch valve (N304 13 240), which includes the vent solenoid valve, in this case.

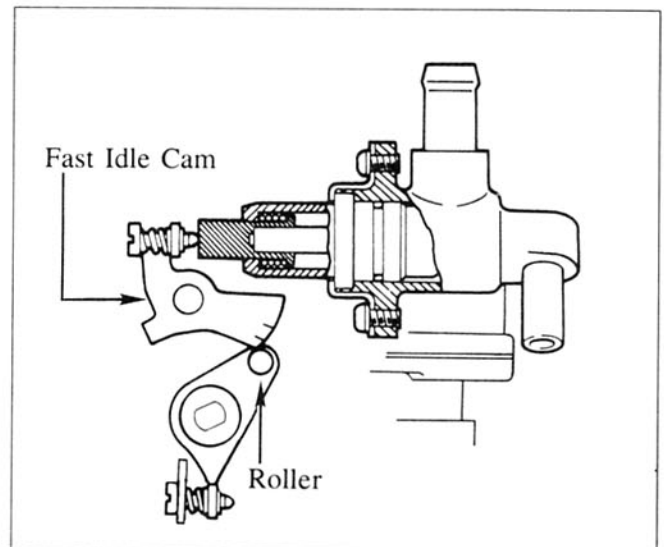
Figure 1

1. Warm up the engine to the normal operating temperature. Confirm that the fast idle cam separates from the roller as shown. If the fast idle cam is contacting the roller, the engine is not fully warmed. (Figure 1)
2. Stop the engine and turn the key to the "ON" position.

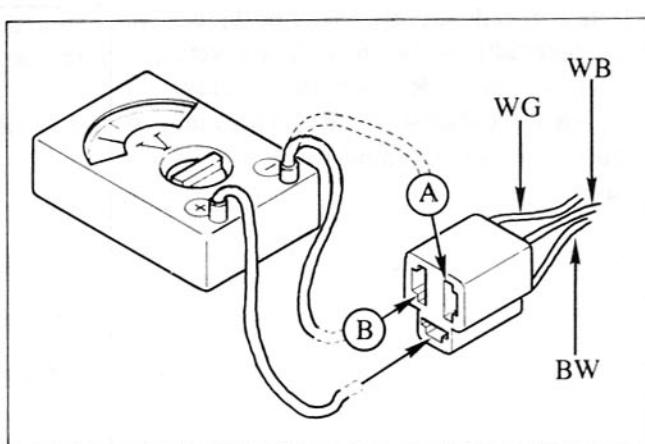
Figure 2

3. Connect the voltmeter to the throttle sensor checking connector (Green) and check the voltage as shown. (Figure 2)

- (a) Terminal **(A)** - approximately 12v & Terminal **(B)** - 0v:
Throttle sensor adjustment is OK.
Go to Step 4.

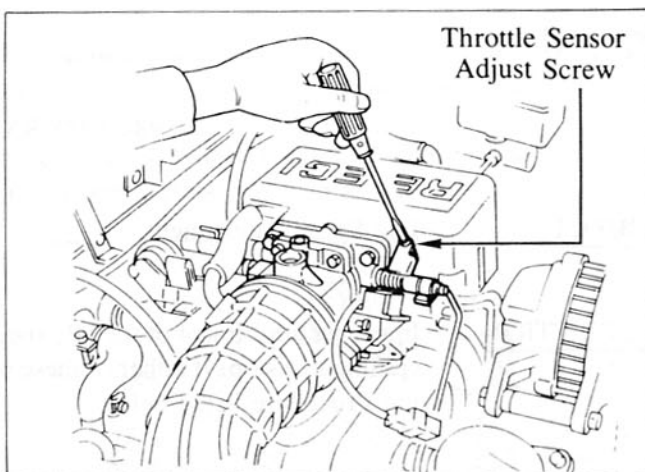
Figure 3

- (c) Terminal **(A)** - 0v & Terminal **(B)** - 0v:
Throttle sensor out of adjustment.
Adjust as follows:

Turn the adjust screw clockwise until the voltage at terminal **(A)** becomes approximately 12v. Then turn the adjust screw an additional $\frac{1}{4}$ to $\frac{1}{2}$ turn clockwise. Confirm that the voltages at terminals **(A)** and **(B)** are as shown in Step 3(a). (Figure 3)

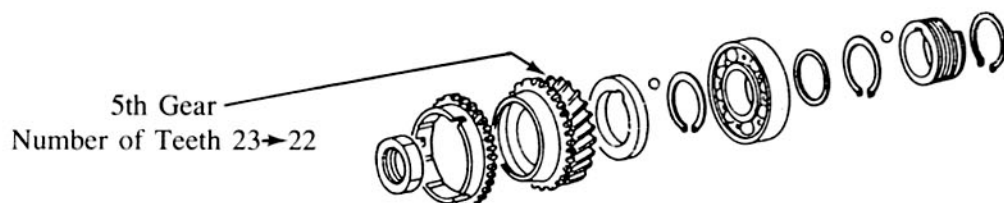
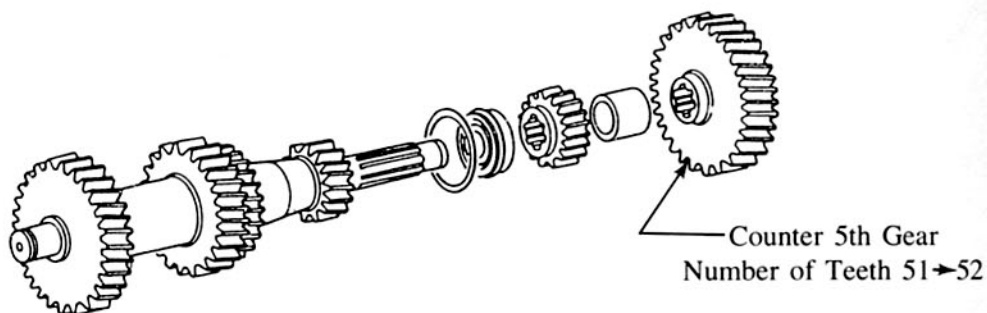
The number of the teeth of the 5th gear and counter 5th gear has been changed since the production date of July, 1984. Because of this change, the gear ratio of the 5th gear has been changed from 0.758 to 0.711.

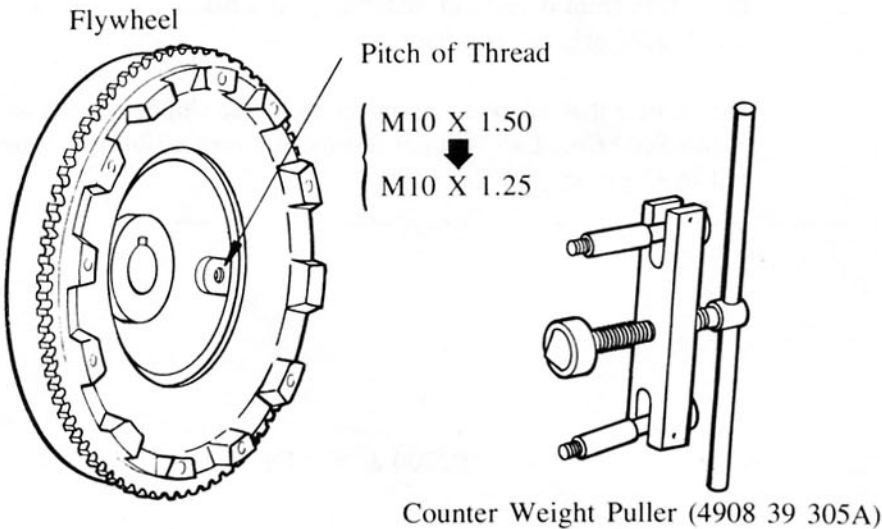
DESCRIPTION The thread pitch of the two holes in the flywheel has been changed from 1.50mm to 1.25mm in order that the same puller can be used to remove the flywheel for manual transmission and the counter weight for automatic transmission. Because of this change, the flywheel puller (4908 23 300A) cannot be used for the modified flywheel. When removing the flywheel, use the counter weight puller (4908 39 305A).

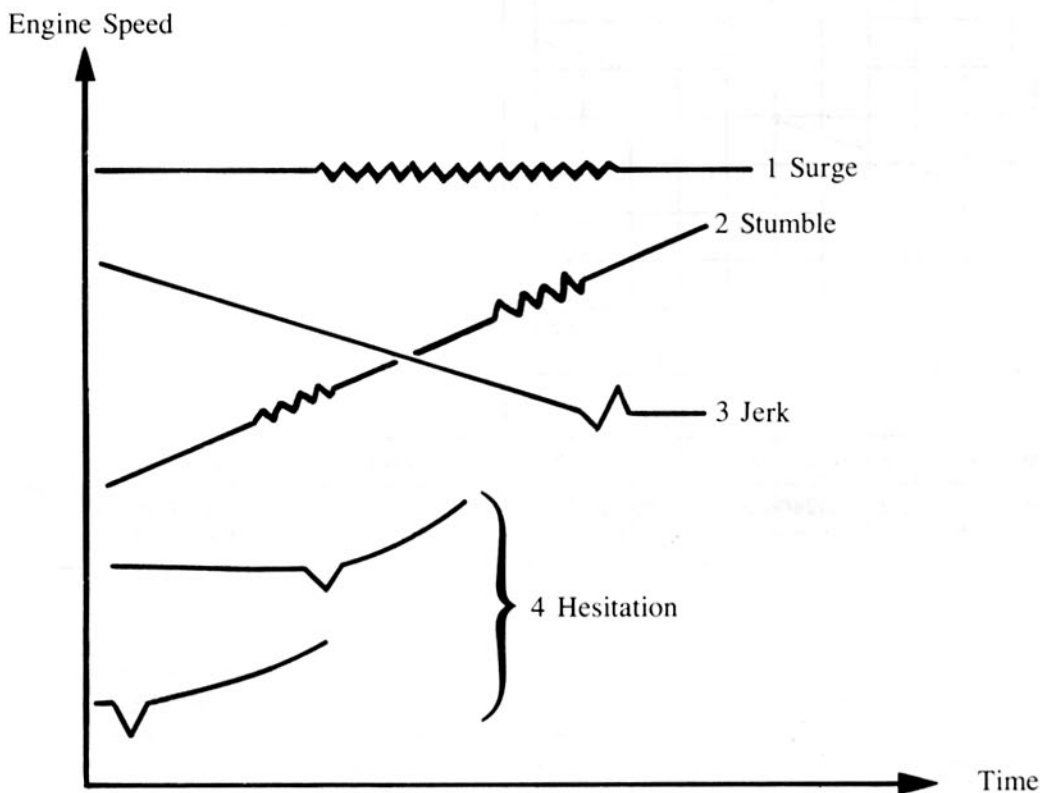
DESCRIPTION To create the same language about driveability problems, you are kindly requested to use the following descriptions in the future.

- (1) SURGE: Continuous soft jerking during cruise.
- (2) STUMBLE: Mild jerking during acceleration.
- (3) JERK: Shock occurring when the gas pedal is pressed just after deceleration.
- (4) HESITATION: Flat spot occurring just after the gas pedal is pressed.

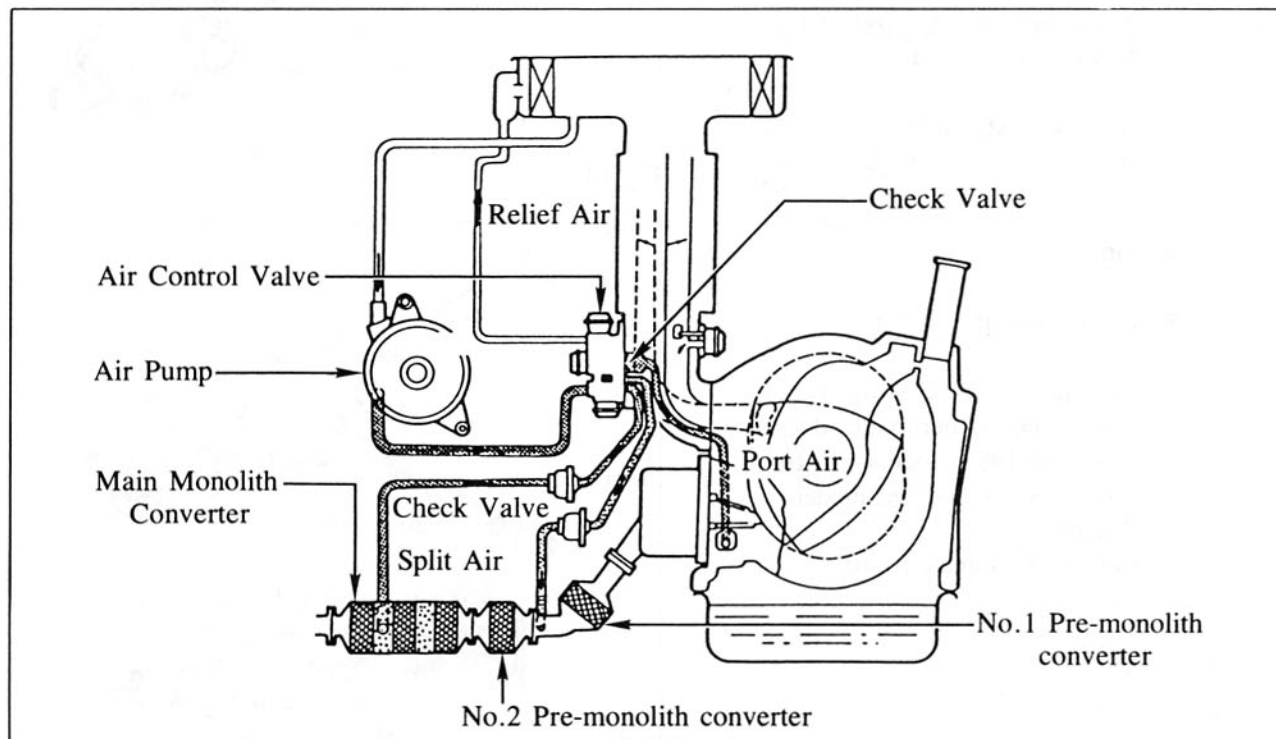
Fig.17

- Air Injection (Figure 17)

The port air switching valve introduced in mid-'84 has been carried over to the 1985 models.
Ref. W/S Manual 4A:18 and 29
