| Section | Applicable Model/s | Subject | Bulletin No. | 001/00 |
| 00 | Multi | TECHNICAL ASSISTANCE HOTLINE | Issued | 11/20/00 |

## BULLETIN NOTE

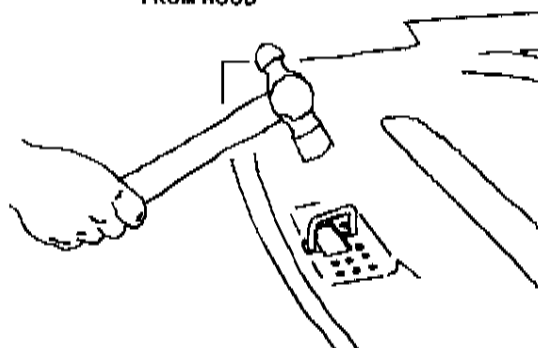
**USE HAMMER TO LOOSEN STRIKER FROM HOOD**

- The striker is epoxied onto the hood. A portion of the hood material may peel off together with the striker. Do not remove the material by force, but detach it by inserting a small screwdriver or scraper between the striker and the hood.

5. Using a ball-peen hammer, hit the striker a few times until it separates from the hood. Remove the masking tape and the striker.

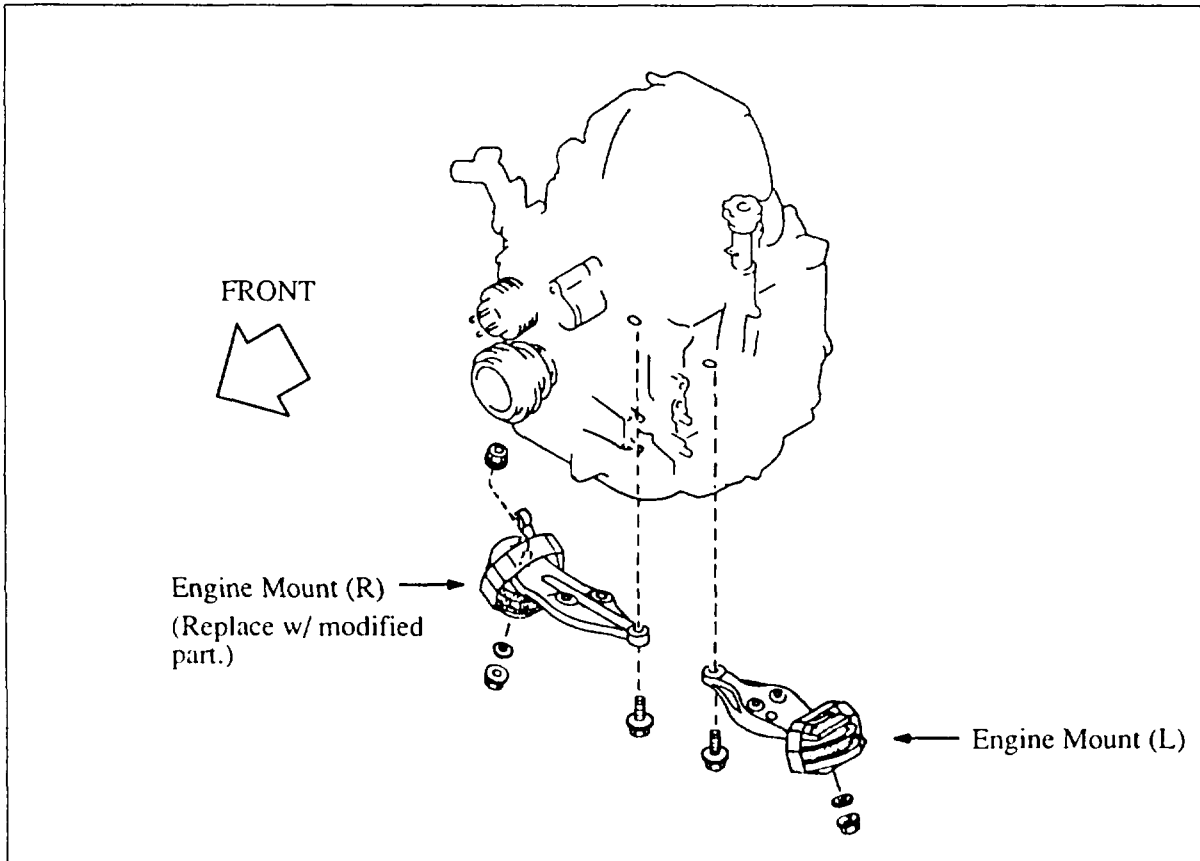
On some vehicles, an unusual noise may be heard from the right engine mount. This noise is most evident during idle or when driving on rough roads and/or speed bumps.

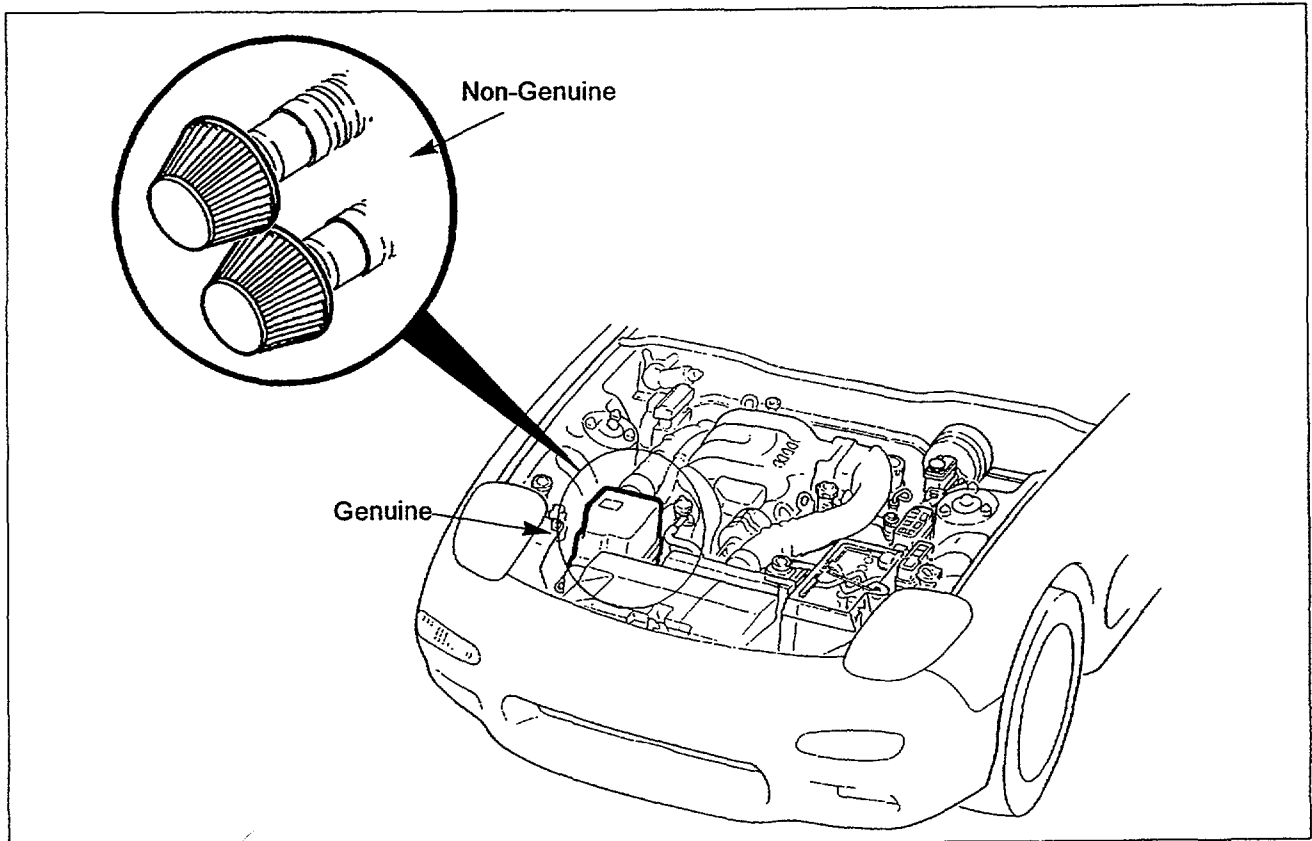
Unlike the original design, non-genuine air cleaners (as shown below) draw heated, engine compartment air into the air pump. This air increases pump temperature which may result in lubrication loss and bearing failure. Customers should be informed that the vehicle warranty prohibits alteration of the emission control system as well as other components.

Recommend that the customer have the original air cleaner installed to prevent non-warrantable component failure.

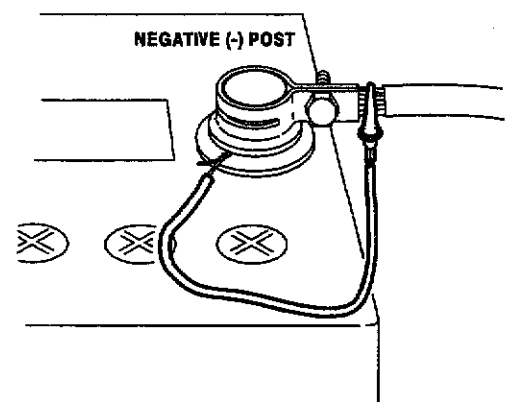
Battery is dead after vehicle sits overnight or for a short period of time. This could be caused by excessive back-up current drawn through the battery after the engine is shut off.

4. Carefully loosen the negative battery clamp without disconnecting it from the post.

5. Slightly lift clamp and wrap the jumper wire around the bottom of the post and attach the alligator clip to the cable clamp.

6. Remove the clamp from post then connect an ammeter as shown.

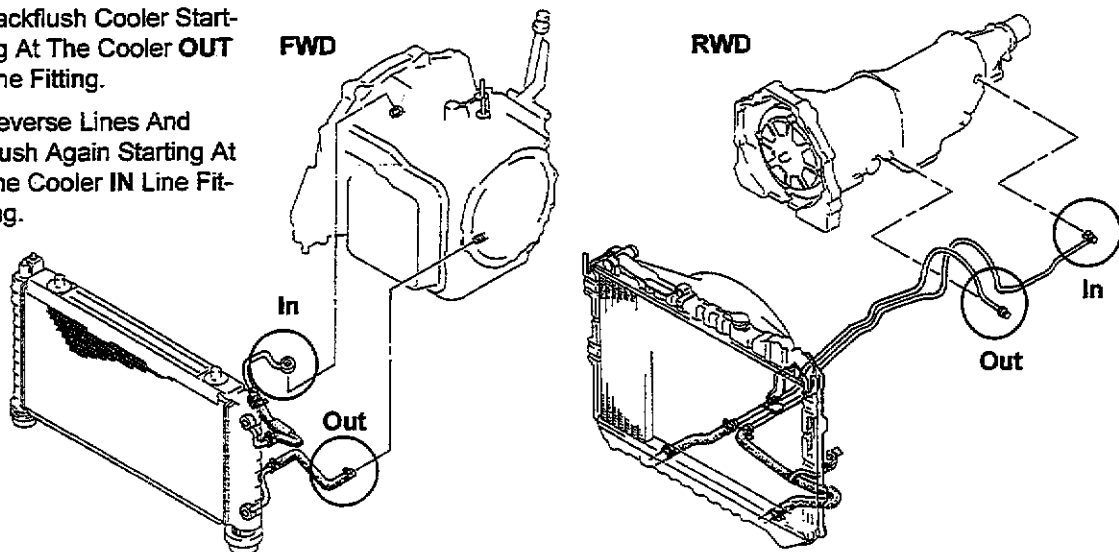
The automatic transmission oil cooler must be flushed whenever performing a major transmission repair or replacement. If the cooler is not flushed properly, residual friction material and metal may become dislodged and affect the new transmission's operation.

- 1) Backflush Cooler Starting At The Cooler **OUT** Line Fitting.
- 2) Reverse Lines And Flush Again Starting At The Cooler **IN** Line Fitting.

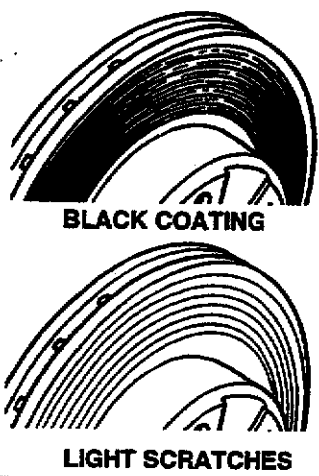
| Concern | Example | Operation | |
|---|---|---|---|
| <b>Other Than Brake Judder</b> <ul style="list-style-type: none"> <li>• <b>Black Coating</b> from abrasion powder adhering to rust spots on the disc.</li> <li>• <b>Light Scratches</b> similar to grooves on an audio record.</li> </ul> | <p><b>BLACK COATING</b></p> <p><b>LIGHT SCRATCHES</b></p> | No | No |
| <b>Cracks In Rotor</b> | <p><b>CRACKS IN ROTOR</b></p> | No | Yes<br>(See Note 1) |

| Concern | Example | Operation | |
|---|---|---|---|
| <b>Rotor Thickness Will Be Less Than Specified (After Machining). Refer to the WSM for limit specifications.</b> | N/A | No | Yes<br>(See Note 1) |

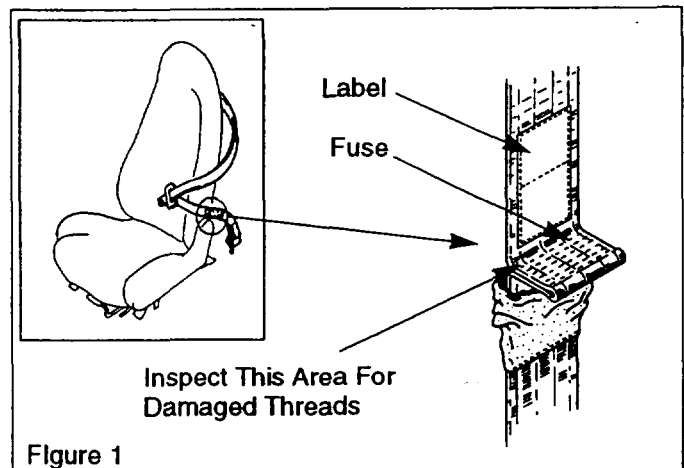
1. Slide the sleeve down to expose the fuse portion of the seat belt.
2. Inspect the area for frayed or broken stitching (See Figure 1).
3. If stitching is damaged, seat belt replacement is necessary. If the stitching is not damaged, the seat belt caution label cover should be stitched in place.

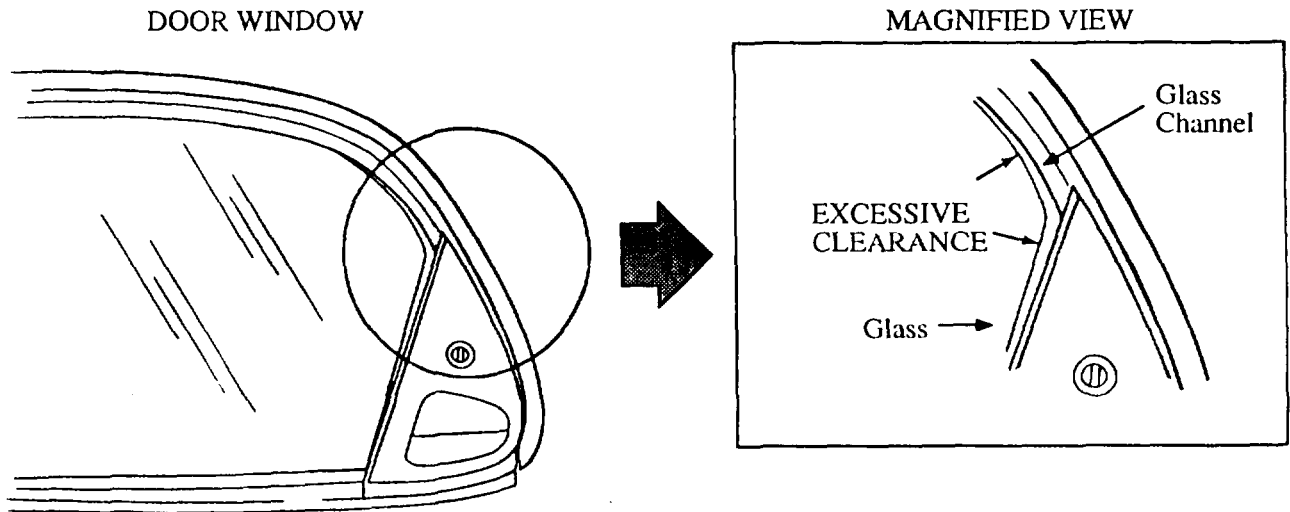
Some vehicles may experience a wind noise from the right and left door windows (near the outside door handles). This noise is due to air entering the cabin area. When completely rolled up, the windows do not fit flush against the glass channel.

Inspect the vehicle for excessive clearance. See figure above. If the above condition exists, replace the affected glass guide(s) with a modified part. See figure on next page. The glass guide has been modified to reduce the sliding resistance between the glass and glass channel. This modification makes the glass fit flush against the glass channel.

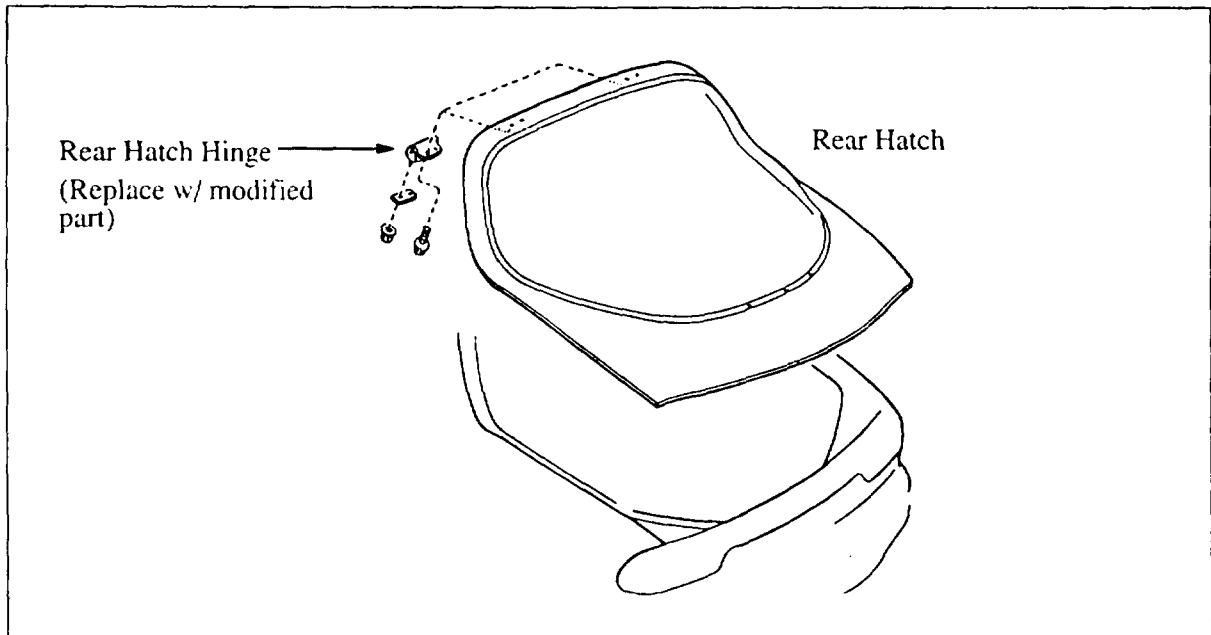
On some vehicles, noise may be heard from the rear hatch hinges. This noise is most evident when driving on rough roads or going over bumps.

If the above condition exists, replace the rear hatch hinges with a modified part. The modified part has been improved to eliminate the noise.

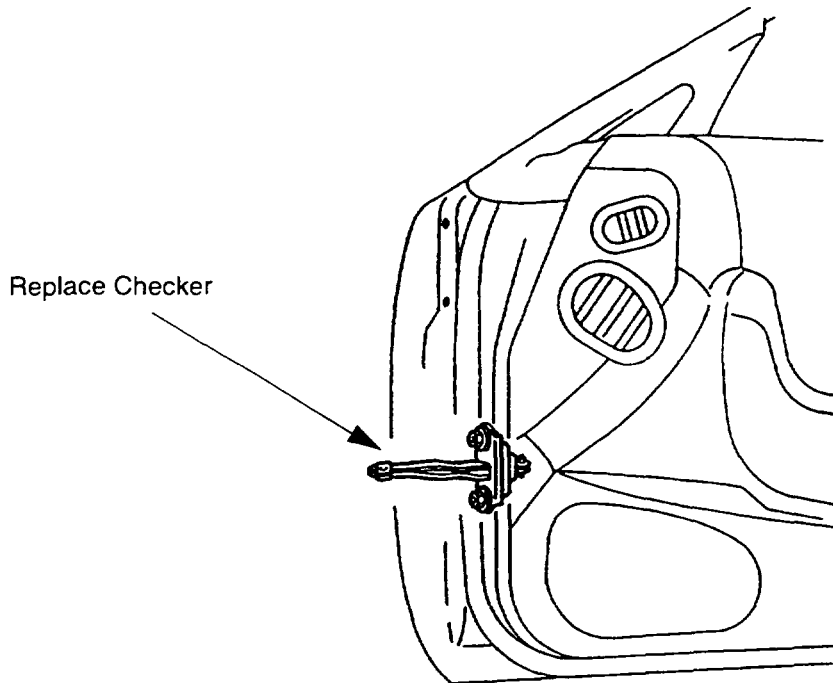
To correct this problem, the checker has been modified.

Follow the procedures listed in section S of the workshop manual to replace the door checker for customers complaining of this noise.

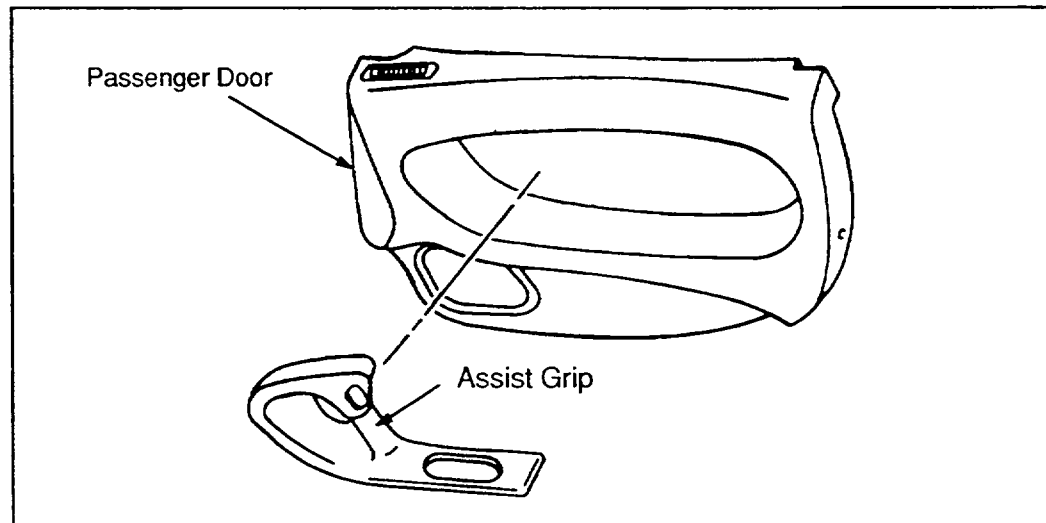
On some vehicles, the passenger door grip may break or become loose. This is due to the constant pulling force when closing the door.

The material used to manufacture the door grip has been improved to reduce the possibility of breakage

If the above condition occurs, replace the door grip with a modified part. Refer to the workshop manual , section S for removal and installation procedures.

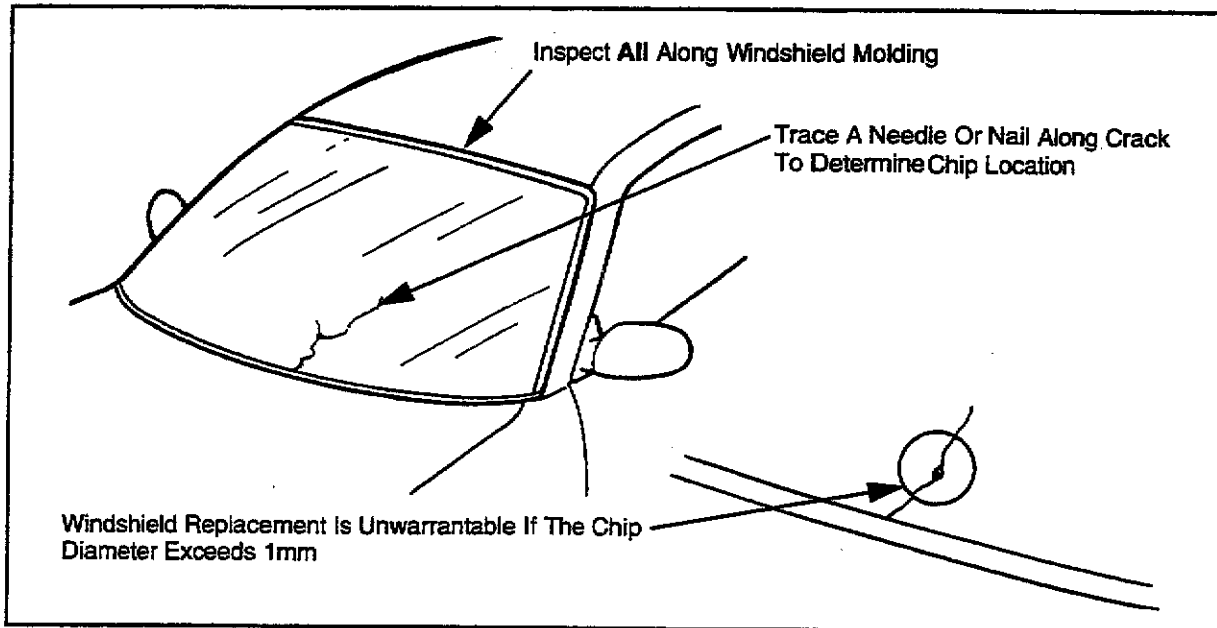
Windshield replacement is not warrantable if a chip larger than 1mm in diameter exists along the length of the crack.

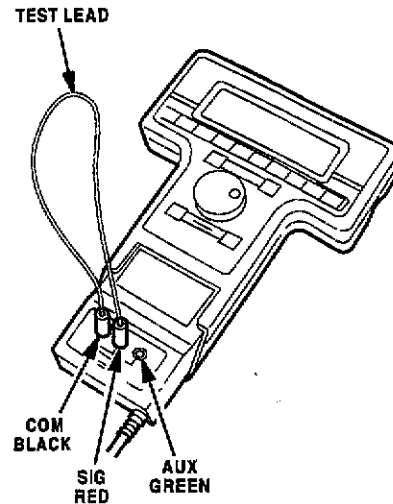
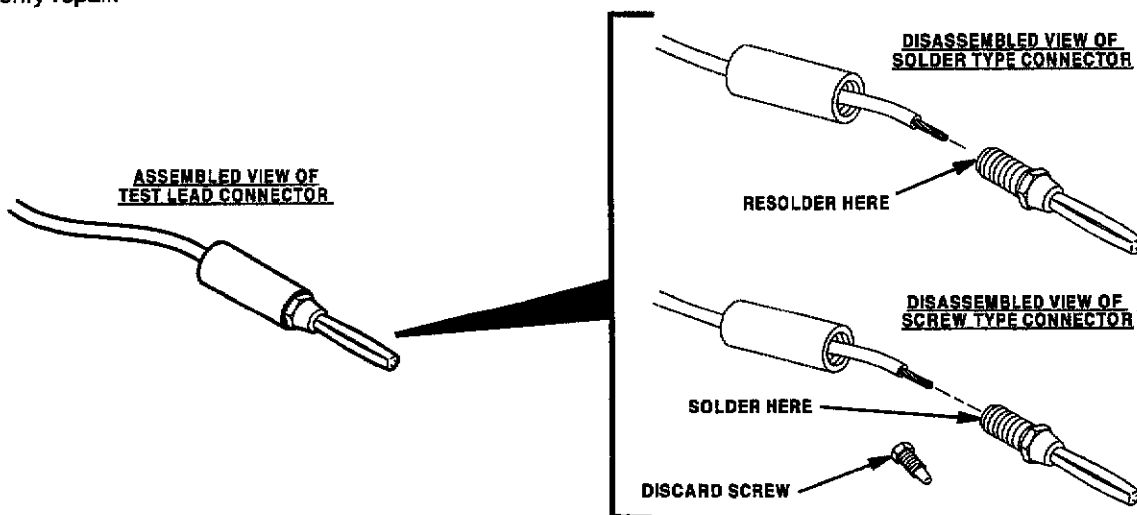
The NGS test lead connectors may become loose or corroded causing incorrect readings. Before using the ohm meter function of the NGS tester for diagnosing electrical circuits, check for excessive resistance in the test leads and connectors and repair them if necessary.

1. Verify concern.
2. Select "Ohm Meter" on the tester and connect a test lead between the COM (black) and SIG (red) terminal on the NGS tester and note the reading.
  - A reading of 0 ohms indicates that the test lead and connections do not have excess resistance.
  - A reading other than 0 ohms may indicate a poor connection (go to STEP 3).
3. Disassemble the connectors and check for corrosion, solder breakage, or looseness. Resolder connections to repair as necessary. Refer to illustration below.
4. Verify repair.

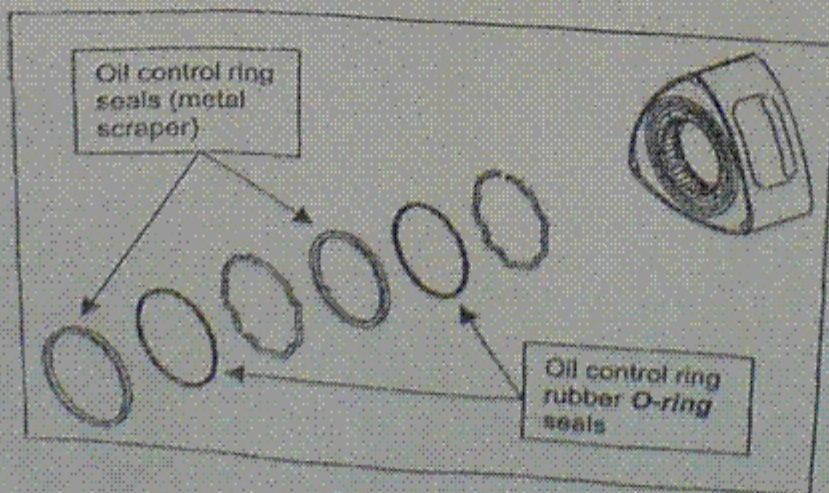
All Pre-Renesis engines have a set of oil control seals in the sides of the rotors (refer diagram below), which are designed to keep the oil from the lubrication system out of the combustion chambers. Each seal consists of a metal 'scraper' with a rubber o-ring within. MC advise this o-ring is not compatible with synthetic oils (or synthetic/mineral blends) and that such oils can attack the material in the o-rings, causing them to break down and deteriorate. Should this occur, excessive amounts of oil would be drawn into the combustion chambers causing high oil consumption, smoke from the exhaust, fouled spark plugs and reduced engine life. **Therefore, synthetic oils or blends are prohibited and only mineral oils must be used in early Rotary engines.**

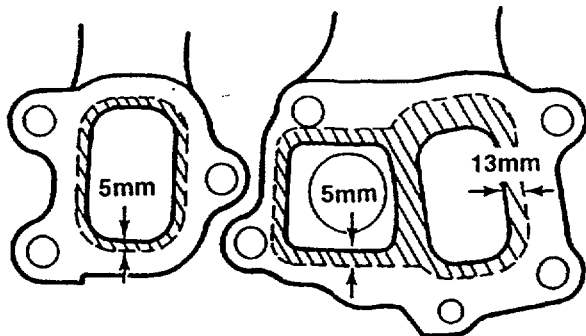
next to the turbo pre-control valve, cracks of 13mm or less are acceptable.

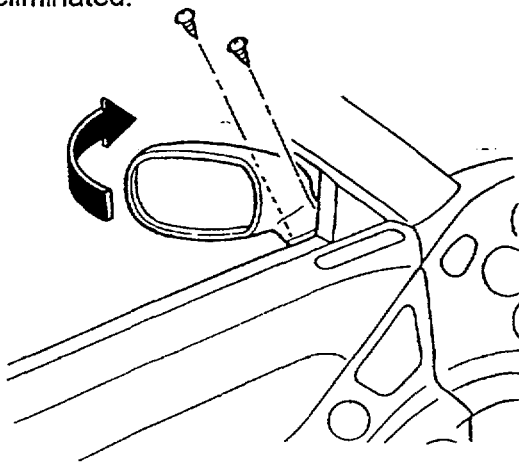
If the left or right door mirrors shake or vibrate under normal driving conditions, or on rough roads, do not replace the door mirror.

Twist the mirror downward to expose the two (2) mounting screws that attach the mirror to the body. Remove the mounting screws and apply loc-tite (blue type) to the threads and reinstall the screws very firmly to ensure the vibration has been eliminated.

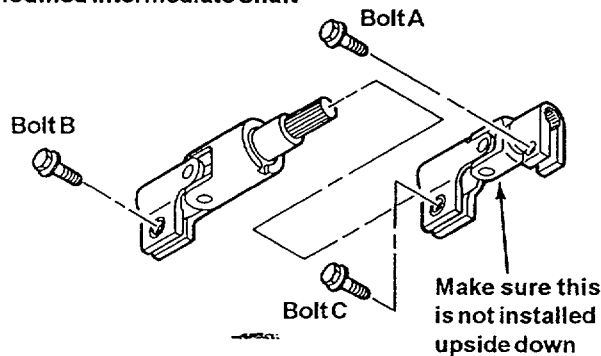
### Modified Intermediate Shaft

**NOTE:** The steering shaft as well as the installation procedure is different from the previous steering shaft (TA02-32-090D). If the shaft is installed incorrectly, the steering wheel effort will feel uneven (hard then easy) while turning. To avoid this uneven steering feel, closely follow the steps below and refer to the illustrations in the April 1995 issue of the M-Tips Newsletter.

1. Make sure the upper portion of the intermediate shaft is not assembled upside-down on the lower portion of the intermediate shaft spline.
2. When installing the shaft, loosen bolt "C" but

DO NOT remove it from the shaft, It is difficult to assemble the spline and the upper portion of the intermediate shaft straight after either part has been installed in the vehicle.

3. Ensure that bolts "A", "B" and "C" are tightened to 14-19 ft. lbs.

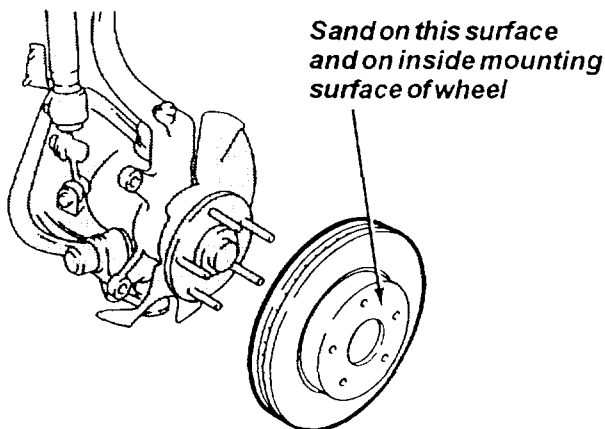
A clicking sound from the outside of either front wheel may occur when the vehicle is moving slowly and turning to the left or right. You may hear several clicks each time the wheel goes round, but they occur irregularly.

To get rid of this condition, remove the wheel and use rough sand paper to clean the disc plate and wheel mounting surface (see illustration). Carefully remove abrasive dust that's produced from sanding and install the wheel. Tighten the lug nuts to 94 ft. lbf.

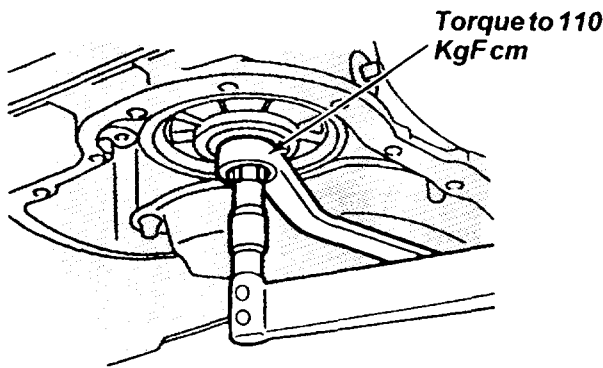
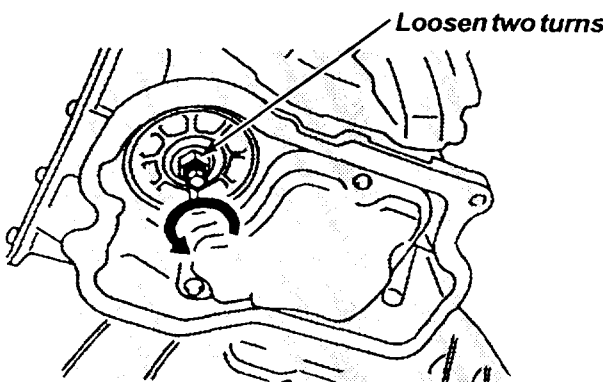
A harsh shift from first to second and second to third may be the result of a tight 2-4 brake band adjustment. To confirm the condition, test drive two equally equipped vehicles and compare shift quality. If you verify the condition, adjust the band according to the Workshop Manual procedure on page K1-111, using the following new specifications for steps 10 and 11:

Step 10 - Torque piston stem to **110 KgF cm**.

Step 11 - Loosen piston stem **two turns**.

Reassemble components and test drive vehicle again, checking this time for shift flare. If flare exists:

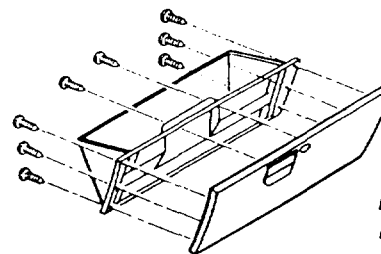
Hinge Screws (2 total)

A glovebox door and hinge that rattles or squeaks may be a result of loose screws. To eliminate this condition, make sure the two hinge screws and the eight inner glove box lid screws are adequately tight.

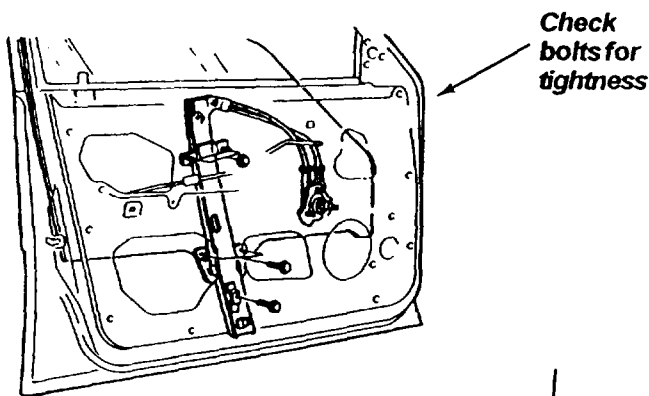
**"Window Regulator Bolts," Cont. 'd**

Do not simply replace the window regulator (manual or power) if the door rattles or if it's difficult to roll a manual window up and down. First check for loose window regulator mounting bolts. Remove the door panel and ensure the bolts are tightened to 61-87 in.-lbs., 6.9-9.8 N.m. (illustration, next pg.).

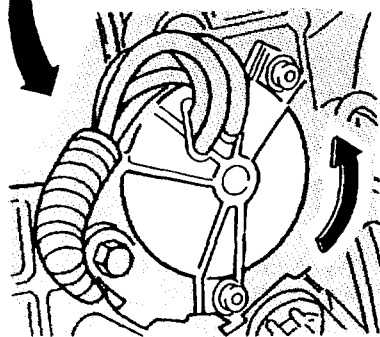
Rotate one notch

An open electrical contact in the change motor position plate may prevent shifts into or out of four wheel drive intermittently. To correct this condition, rotate the plate cover one notch counterclockwise after loosening the three cover screws.

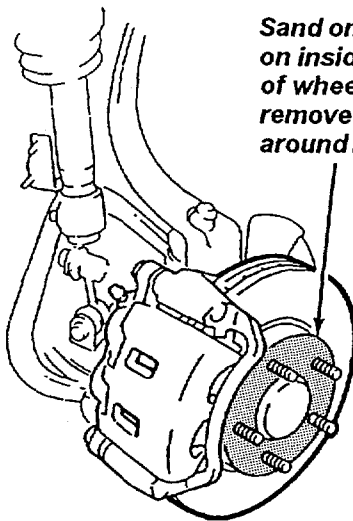
You probably don't need to replace any parts if a customer complains the vehicle's front wheels make a clicking sound. Often, several clicks can be heard from the outside wheel during a slow turn.

We featured this concern in the June issue of *Mazda Tips* and the fix still applies: remove the wheel, then use coarse sandpaper to clean the disc plate's contact area and the wheel mounting surface (see illustration). Carefully remove the abrasive dust produced from sanding and re-install the wheel. Tighten lug nuts to a maximum torque of 94 ft. lbs.

*Sand on this surface and on inside mounting surface of wheel. You don't need to remove brake rotor (sand around bolts).*

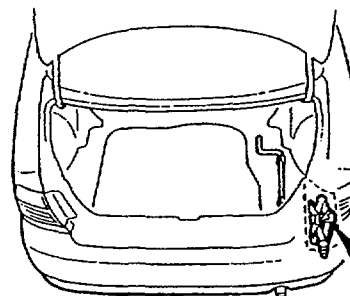
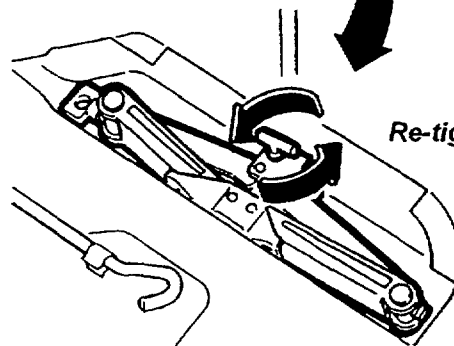
*Re-tighten by hand*

The spare tire jack wing bolt may be too tight. During PDI, make sure you can loosen the bolt by hand. If you can't, loosen it with a suitable tool and re-tighten it by hand until it is finger tight. Then, tighten it another eighth of a turn by hand.

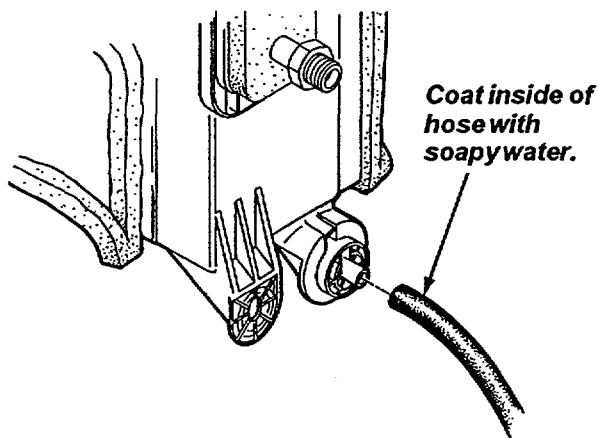
Water from the air conditioning evaporator case could leak onto the front passenger's side carpet because the case's drain hose may fall off.

Before you attach the end of the hose onto the case, coat the first 40 mm of the inside of it with soapy water. This will create a bond with the case's spout that is sticky enough to prevent the hose from falling off again.

Be sure to re-insert the hose completely and check that the other end is routed through the firewall grommet.

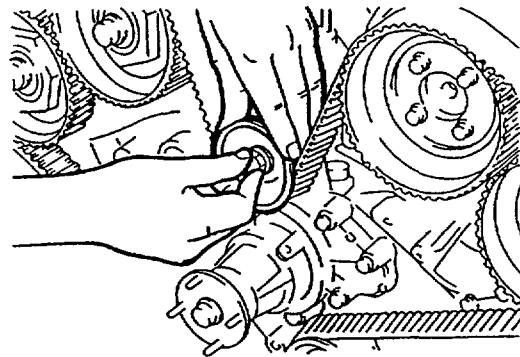
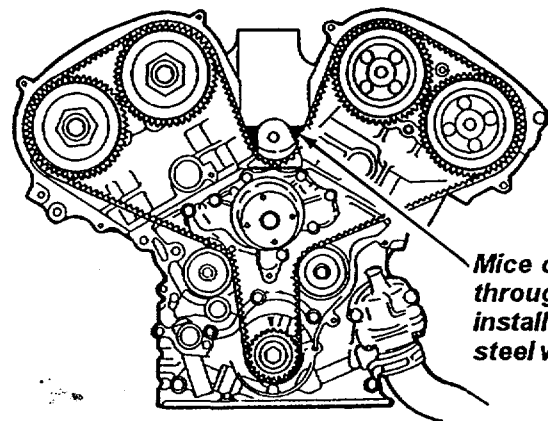
*Remove No. 2 Idler Pulley to see gap.*

Mice may cause the belt to jump teeth. In cold climates especially, they can crawl through a gap between the two cylinder heads and possibly build a nest on the belt. When the engine starts up, this interference may force the belt off track.

If you discover this condition, you can prevent it by cleaning and re-setting the belt, then putting stainless steel wool in the gap. You must remove the No. 2 Idler Pulley to get to the gap (see WSM pages B12 to B15). Don't use plain steel wool because it will rust.

Next, clean the engine surfaces around the wool and apply high-temperature silicone around it. This will form a seal to the surface and reinforce the blockage.

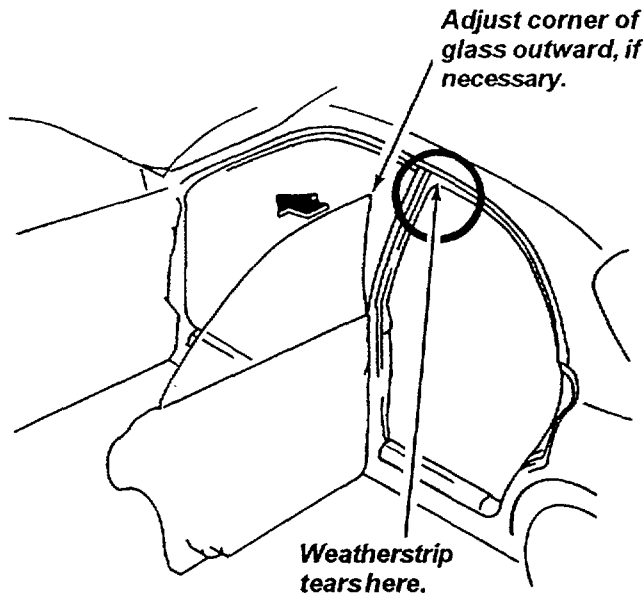
A torn weatherstrip at the rear door's upper front corner may cause wind or water leaks. In

time, the weatherstrip could tear if a slightly misaligned door glass digs into it when the door is closed.

If the weatherstrip is torn, install a new one, but ensure the door glass is properly adjusted. If the glass is set too far inward, adjust the corner slightly outward, according to the Workshop Manual procedure (page S-22). Be careful not to adjust it too far outward or you'll create another wind or water leak.

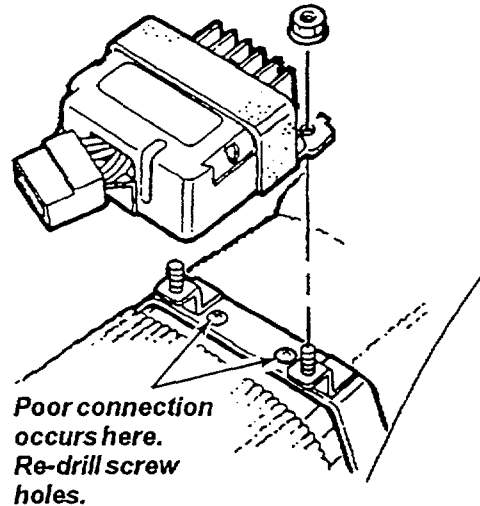
The poor connection results from stripped screw holes on the bracket. Redrill the screw holes and use either larger machine screws or rivets. You might also consider installing a separate ground wire to the vehicle body.

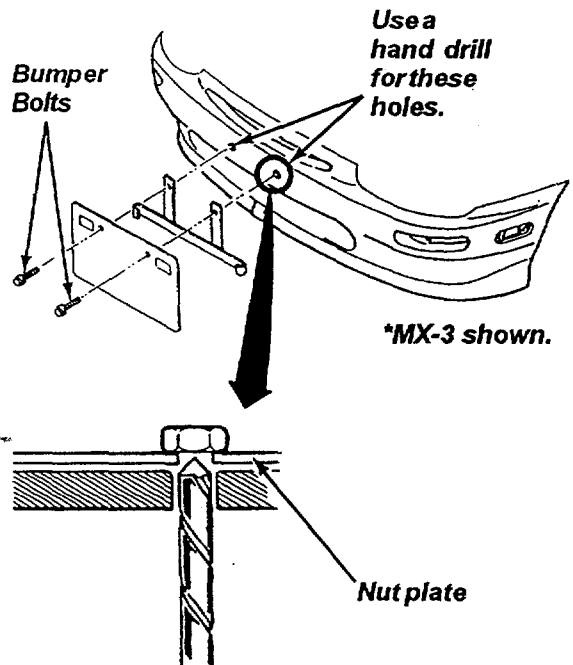
When you drill the holes to install the license plate frame, do it by hand. If you use a power drill, the nut plate attached to the inside of the bumper could come off.

The nuts on this plate anchor the bumper bolts you use to install the license plate frame. And if the nut plate comes off, you must remove the bumper to repair it.

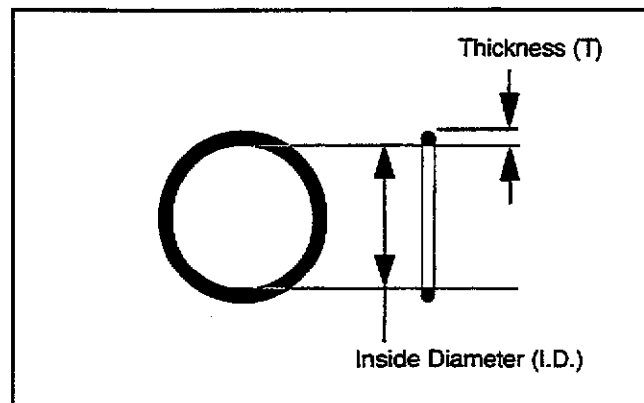
The illustration to the right indicates where the o-ring must be measured to determine diameter and thickness. Use this information and the chart above to identify the proper part if the o-rings are accidentally mixed.

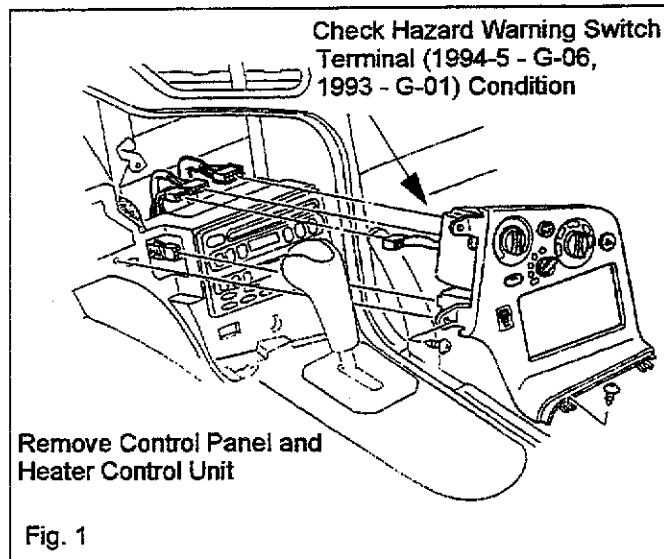
These conditions may be caused by insufficient contact at the hazard switch connector (1994-95 - G-06, 1993 - G-01).

1. Verify the complaint.
2. Remove the control panel and the heater control unit. Refer to section G of the BETM for removal instructions.
3. Check the hazard warning switch terminals. Refer to page 2 of 2 for problem examples.
  - If the female terminals are damaged (expanded), remove the switch from the A/C control unit and replace it with a new part.
  - If the terminals are normal, re-assemble and test. If problems still exist, refer to the BETM or workshop manual for troubleshooting information.

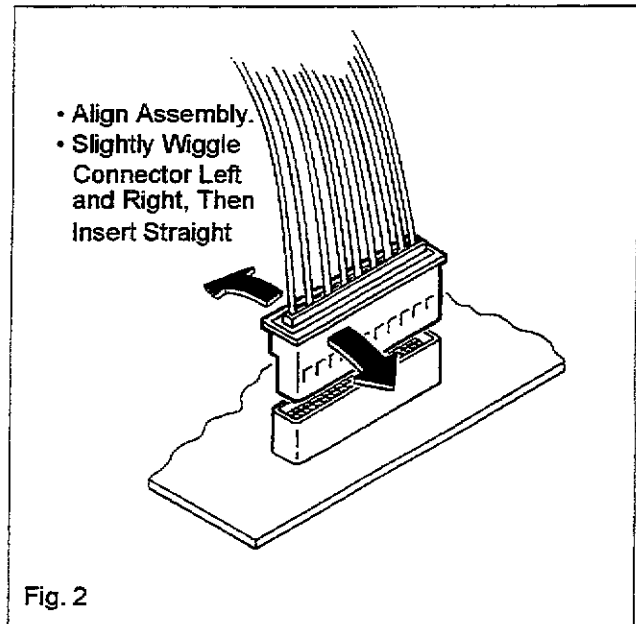
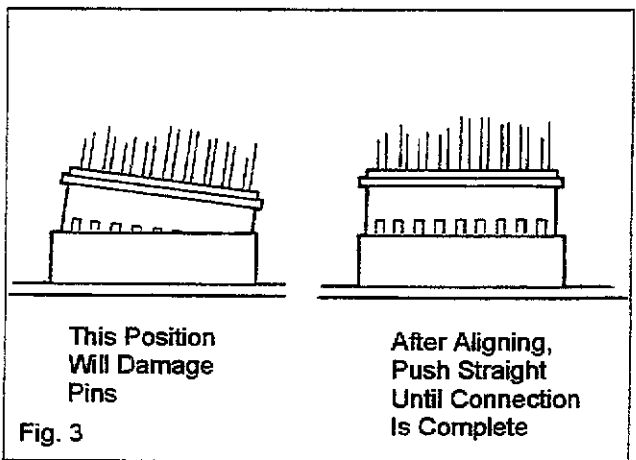
1. Hold the housing when connecting and disconnecting.
2. To avoid connector pin damage:
  - align the connector and housing at the appropriate angle.
  - Slightly wiggle the connector right and left then slowly insert **straight** into the assembly Refer to Fig. 2 and 3.
  - Avoid forcing the connection or mis-alignment.

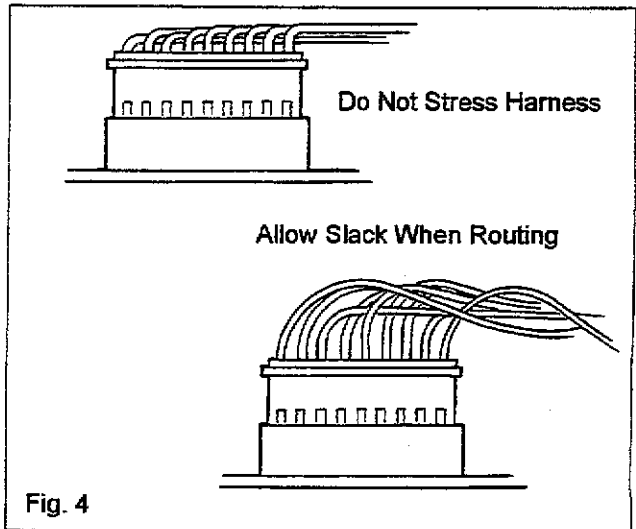
1. **Do Not Stretch** harnesses to connect connectors.
2. Route harnesses to provide slack in harness and no stress on connector. Refer to Fig 4.
